Troubleshooting uBR Cable Modems Not Coming Online

Document ID: 16510

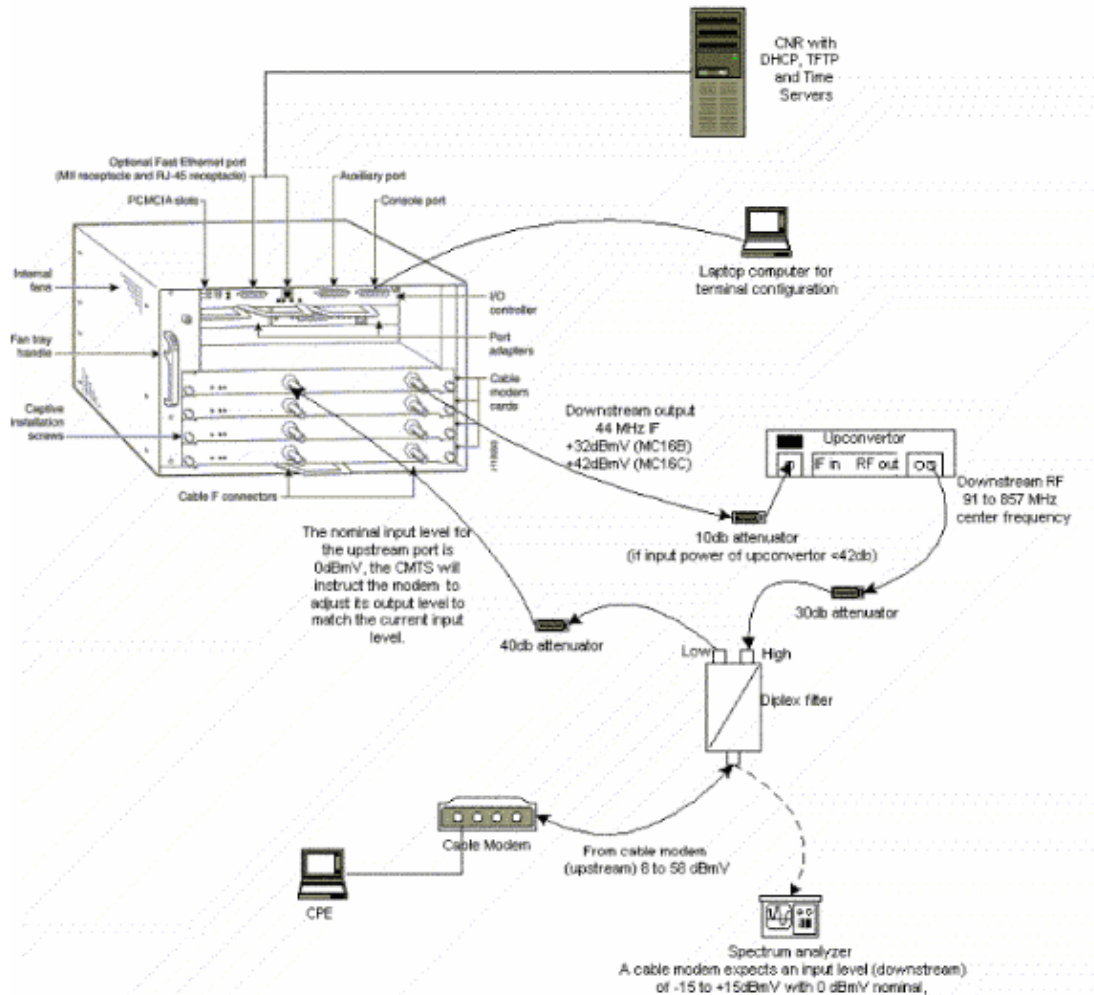
Note: Before starting to troubleshoot any state it is important to look at the state of all the Cable Modems to see whether or not this state applies to all the modems or just a few, and whether this is a new or existing network. If it is an existing network, then investigate any recent changes. In most parts of this document it is assumed that the problem affects all Cable Modems and the following lab topology is applicable:

The above setup can be used for troubleshooting purposes, and rules out RF issues, since this setup excludes Cable TV signals.

If a modem cannot proceed out of ranging state, the likely cause is an insufficient transmit power level. In the setup above transmit power can be adjusted by adjusting attenuation at the low frequency port. Increased attenuation will result in increased transmit power levels. Roughly 20 – 30 dB of attenuation is a good place to start. After initial ranging `init(r1)` the modem proceeds onto `init(r2)` which is where the modem must configure the transmit timing offset and power level to ensure that transmissions from the modem are received at the correct time and are at an acceptable input power level at the CMTS receiver. This is performed through a conversation of unicast RNG-REQ and RNG-RSP messages. The RNG-RSP messages contain power and timing offset corrections the modem must make. The modem continues to transmit RNG-REQ and perform adjustments per RNG-RSP until the RNG-RSP message indicates ranging success or ranging complete by reaching the `init(rc)` state. If a modem cannot proceed out of `init(r2)` the transmit power needs to be refined. Below is an output display of a CM in `init(r2)` state.
